O-ring troubleshooting guide

Developed by the Kalrez® division of DuPont Performance Elastomers

How to assess seal failure

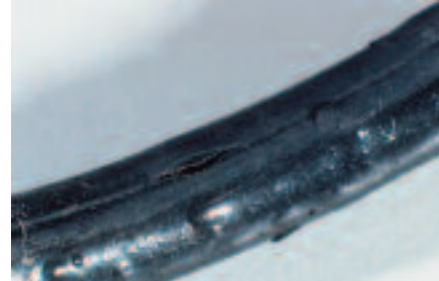
No. 1 Chemical attack

- Numerous small blisters and fissures (cracks and splits), high gloss surface.
- Entire O-ring surface is damaged because sample was completely immersed.

- Very aggressive chemicals attacked the basic polymer structure.

- Select a different elastomer compound that is compatible with the process chemicals.

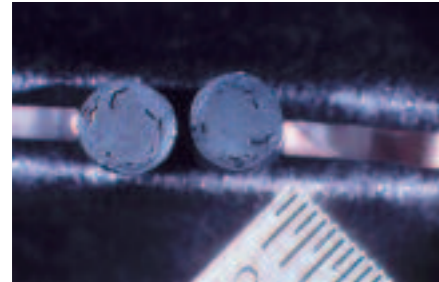
No. 2 Chemical attack

- O-ring surface has blisters and cracks with numerous internal fissures.
- O-ring is dimensionally elongated.

- Very aggressive chemicals attacked the basic polymer structure.

- Select a different elastomer compound that is compatible with the process chemicals.

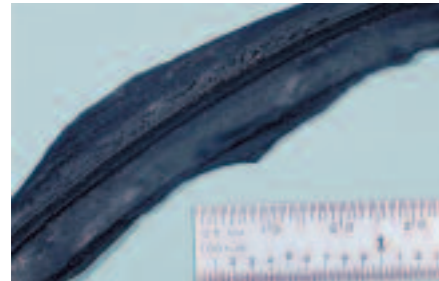
No. 3 Chemical attack

- O-ring softened and swelled resulting in extrusion.
- O-ring filled the entire groove and extruded in two directions, even against the fluid pressure!

- Very aggressive chemicals attacked the basic polymer structure.

- Select a different elastomer compound that is compatible with the process chemicals.

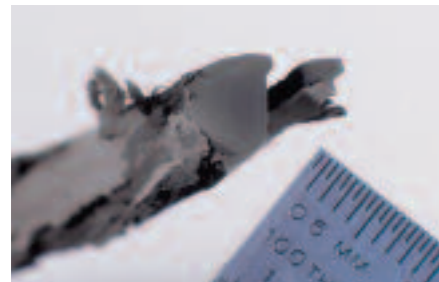
No. 4 Chemical attack

- O-ring is discolored and cracked. Surface is corroded.
- Small cracks extend into the cross section and O-ring surface.
- Excessive compression set and some extrusion are present.

- Primary failure mode is oxidation of the carbon black. Some examples of oxidizing chemicals are nitrous oxide, chlorine dioxide, etc.

- Switch to non-carbon black filled compound to prevent oxidation of the filler.
- Review groove design to optimize O-ring compression.

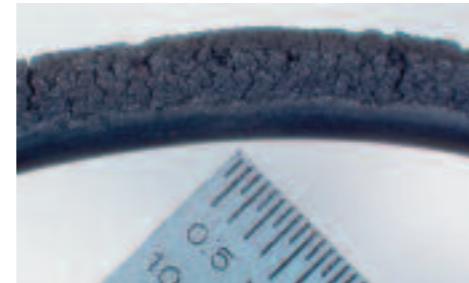
No. 5 Chemical attack

- O-ring shows signs of swell with embrittled particles on outer edge.
- Radial-oriented cracks are present along the outer diameter.
- Surface area exposed to the chemical has damage.

- Chemicals permeated into the O-ring and polymerized inside the elastomer; this is often accelerated with heat. Some examples of these types of chemicals are styrene, butadiene, methyl methacrylate, methacrylic acid, etc.

- Select higher modulus (tougher) compounds to improve mechanical strength.

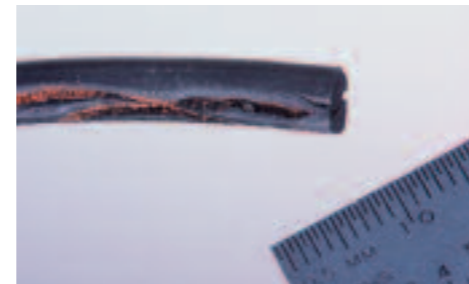
No. 6 Thermal failure

- Extreme damage to O-ring including compression set, cracking, and splitting.
- No indication of elastomer extrusion.

- High temperature excursions beyond the capability of the elastomer. Temperature caused elastomer to swell and created insufficient room in the groove. The resulting compressive forces exceeded the modulus at the highest stress location (the cross section) and split the O-ring.

- Reduce application temperature, minimize high temperature excursions or select an elastomer with a higher temperature capability.
- Confirm proper groove design after reducing process temperature or changing the elastomer.

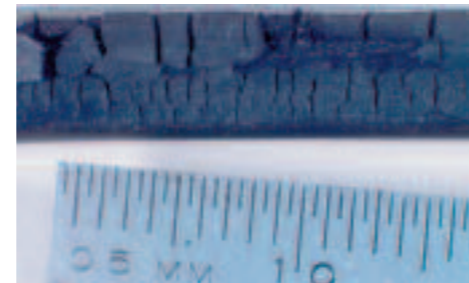
No. 7 Thermal failure

- Inner diameter of O-ring has fine, regular cracks with some particles of O-ring broken away.
- O-ring has taken the shape of the groove.

- High temperature broke performance of the elastomer structure.
- Gland compression and fluid pressure caused compression set and cross section to take the groove's shape.

- Reduce application temperature, minimize high temperature excursions or select an elastomer with a higher temperature capability.

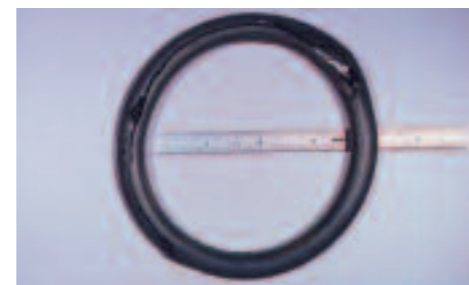
No. 8 Mechanical failure

- O-ring flattened out and split.

- Overcompression. PTFE O-ring replaced by an elastomer O-ring. PTFE O-rings are designed to be crushed unlike elastomer O-rings. Elastomer O-ring compression in service was greater than 30%, almost twice the suggested value.

- Redesign groove and/or reduce O-ring cross section to reduce compression as appropriate for the elastomer.
- If redesign or reduced cross section is not possible, consider a higher modulus (tougher) compound for improved mechanical properties at high compression.
- Be cautious when substituting different O-ring materials for existing materials.

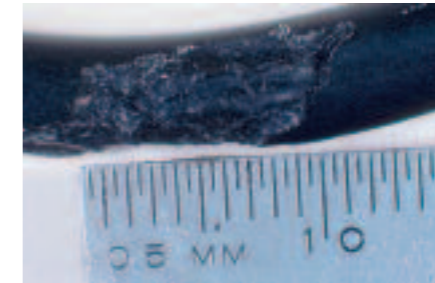
No. 9 Mechanical failure

- Mechanical abrasion on O-ring in a slightly spiraled orientation along the outer diameter.
- "Moonscape" surface appearance indicates chemical attack, however damage is not uniform along the surface exposed to the fluid.

- O-ring was pinched or rolled during installation or while in service (dynamic applications).

- Insure installation procedures do not cause twisting of O-ring.
- Proper groove design ensures that the O-ring will not twist, roll or get pinched in dynamic applications.
- Use anti-extrusion ring and reduce clearance gaps to minimize pinching.

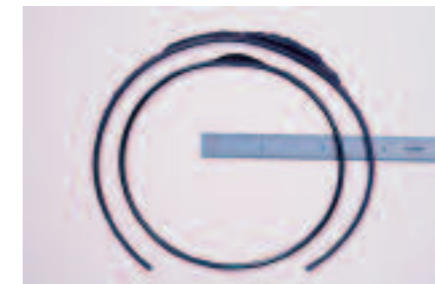
No. 10 Mechanical failure

- Extrusion evident at one specific sealing location along the O-ring.
- Compression set and minor extrusion evident along low-pressure side of rings.

- O-ring used to seal reciprocating piston at high temperature and high pressure beyond the capability of the elastomer (lower modulus elastomers are more susceptible to extrusion at high temperatures).
- Localized extrusion indicates piston was not properly centered.

- Select higher modulus compound to resist extrusion due to the high pressure.
- Use anti-extrusion rings to minimize extrusion due to high pressure.
- Piston applications require the piston to be centered.

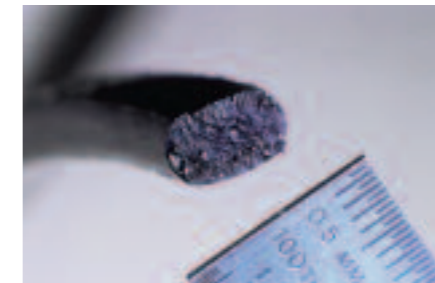
No. 11 Mechanical failure

- Numerous cracks and fissures are visible throughout O-ring cross section.
- O-ring feels soft to the touch due to the numerous fractures inside the ring.
- Severe cracks and fissures along the length of the O-ring, where fluid contacted the O-ring.

- Fluids under high pressure permeated the O-ring. When rapid depressurization occurred, expansion of the fluid occurred too rapidly for the fluid to permeate out of the O-ring. The result is that the fluid literally blows its way out of the O-ring causing cracks and possibly large parts of the O-ring to be missing.
- Carbon dioxide is often associated with explosive decompression.

- Eliminate rapid system depressurization.
- Select higher hardness/modulus compounds with better internal strength.
- Design system with minimal free volume at operating conditions to minimize damage due to explosive decompression.
